# CT Scan of a Meade 2045D SCT

Daniel W. Rickey, Ph.D.

2003-10-24

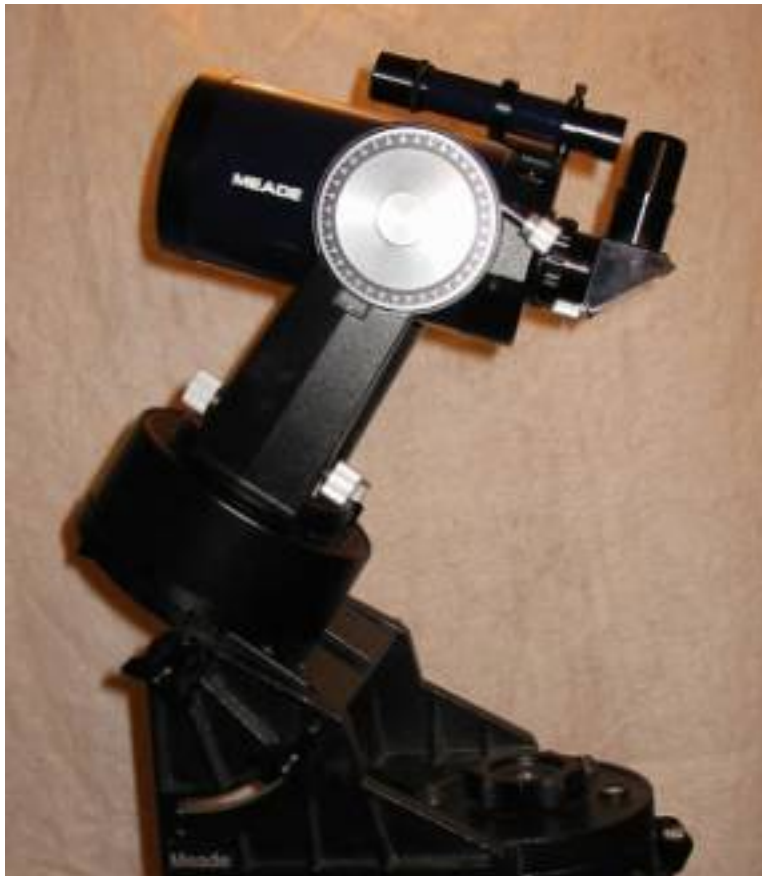
Figure 1. The Meade 2045D on its optional wedge and tripod. The scope also has three small legs so it can sit on a table top.

DWR recently renewed his interest in astronomy and decided to get it working again. Unfortunately the image quality wasn't what he expected it should be. After reading the book on star testing by Harold Suiter, it was obvious that the scope's optics were out of alignment (collimation). Removing the eyepiece and looking into the scope confirmed that things were indeed not right. The secondary mirror looked as if it was off centre

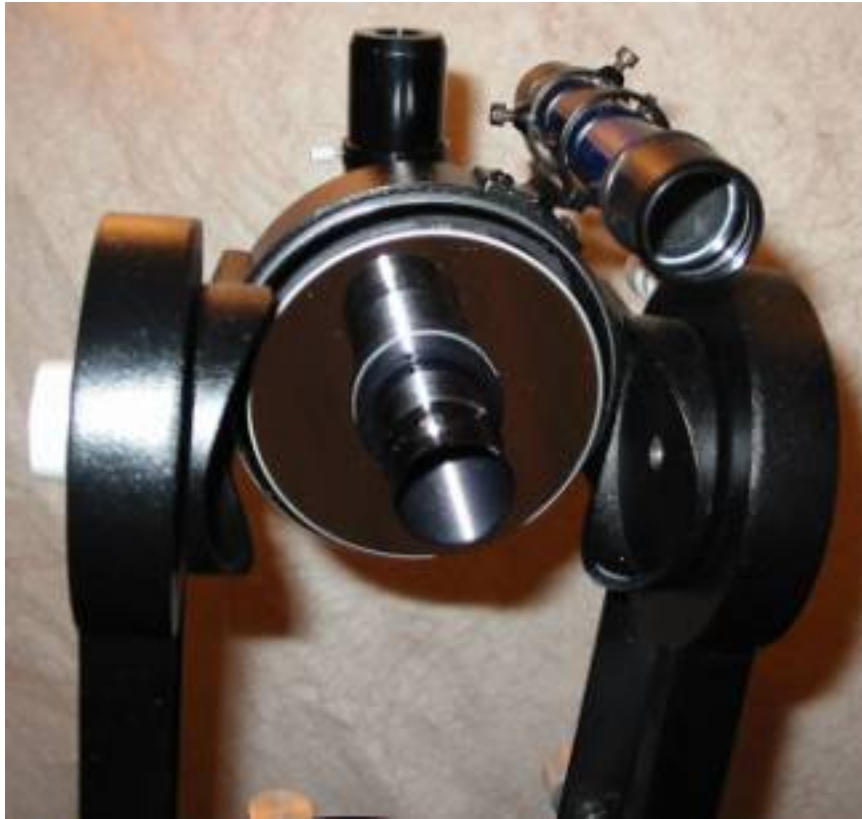
from the tube that the primary mirror slides on. Unscrewing the entire tube from the scope (see Figures 2 and 3) confirmed that there was no obvious problems, but it was hard to tell if the mirror tube and central tube were aligned. Looking into the scope is very confusing because of the reflections from the two mirrors.

Figure 2 Here is the scope without its tube. You can see how the primary mirror slides on a central tube.

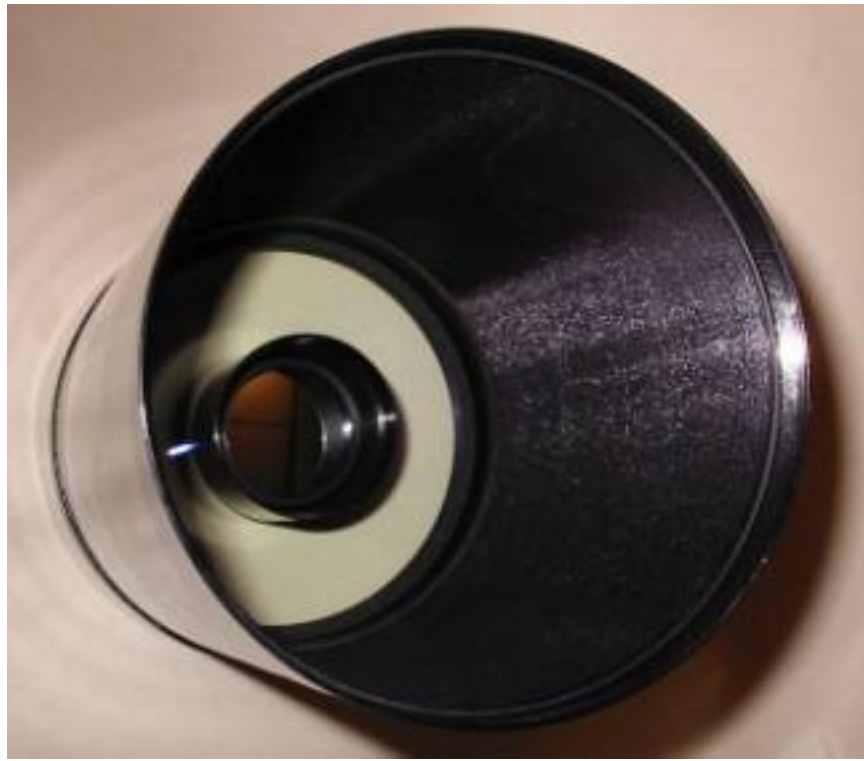
Figure 3 This is the inside of the tube and shows the curved secondary mirror, which sits down inside of a cup. Note the colour change resulting from the coated corrector lens.

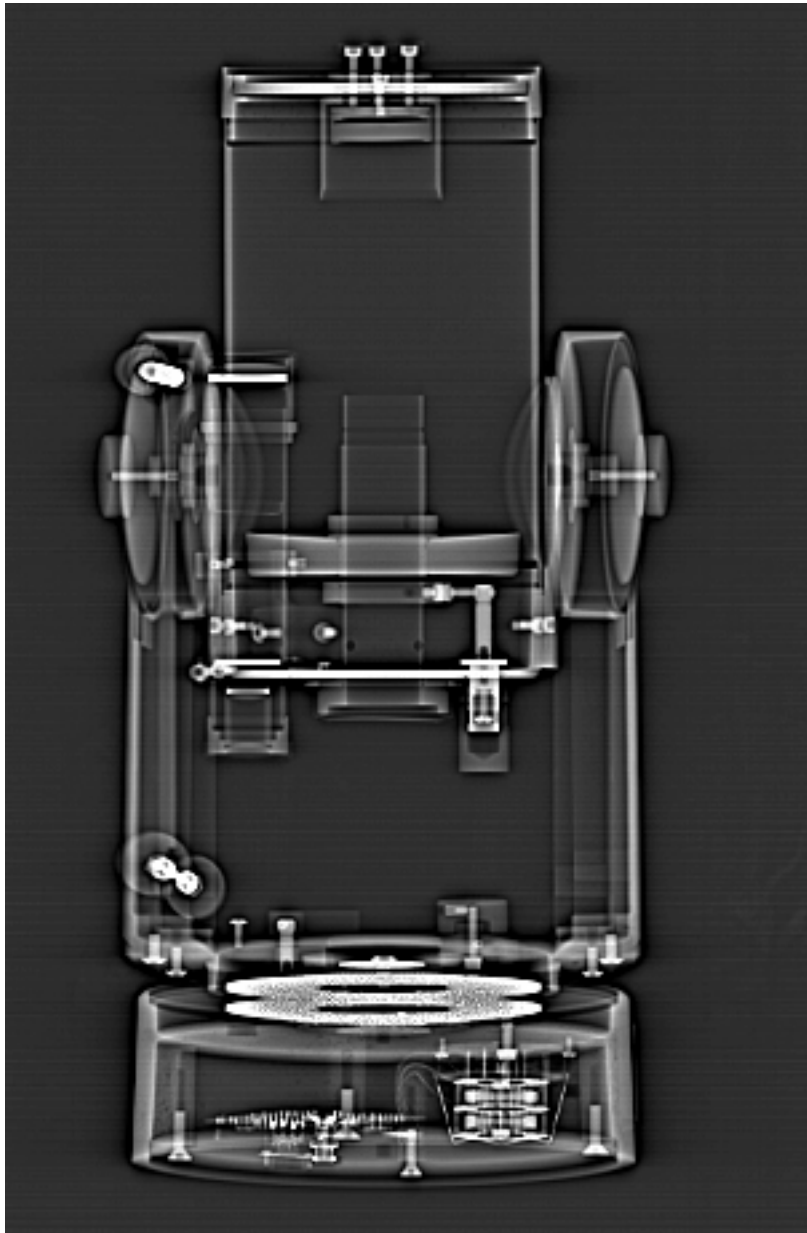
When performing a CT scan, the first images acquired are scout views. These are a lot like normal x-ray films and are used to show the location of each CT image. Figure 7 shows a scout view of the scope projected top to bottom. This scout view very nicely shows the location of the scope's innards. In order to orient the reader, the components in this image have been labeled and the result shown as Figure 8.

Figure 7. Scout view of the scope showing the location of the scope's innards.

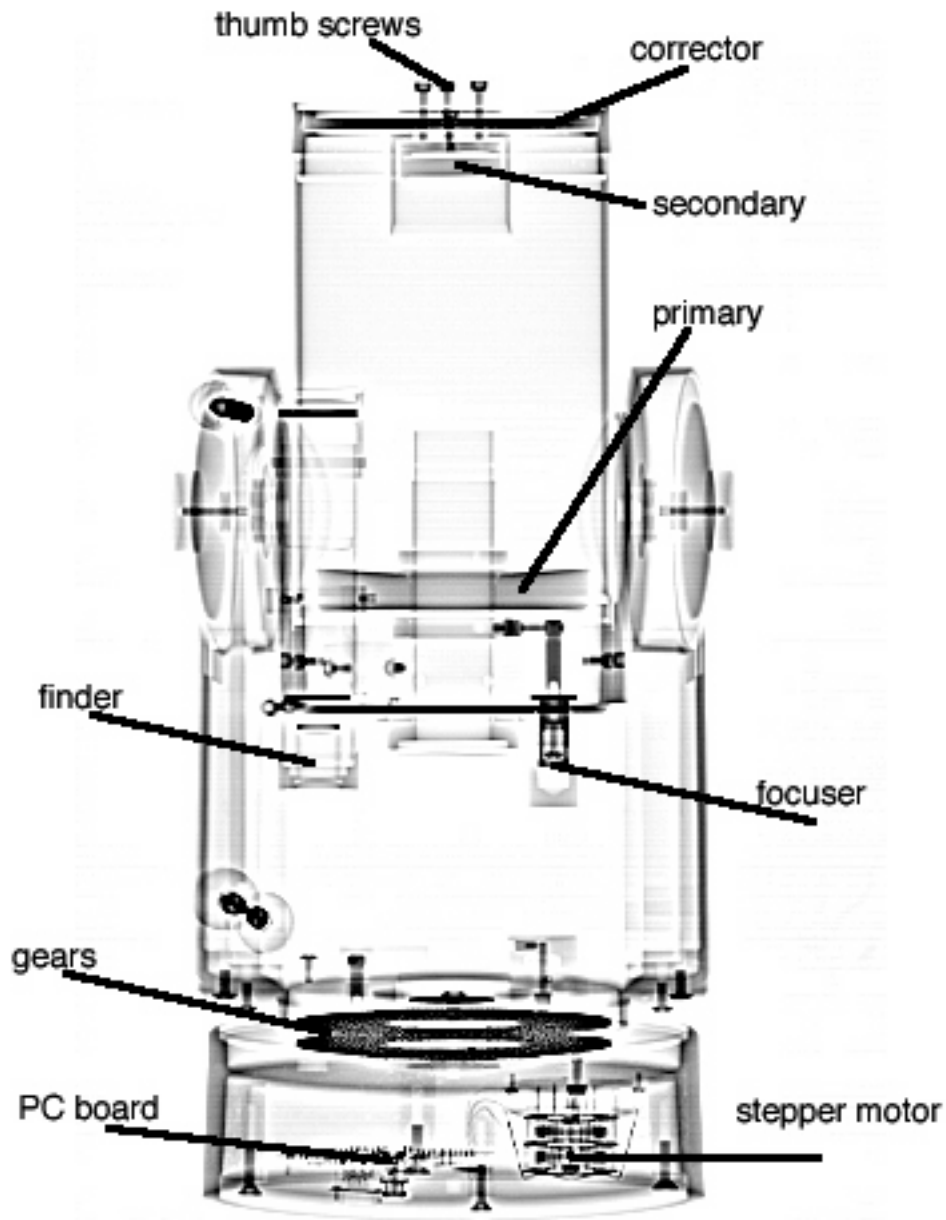
**Figure 8.** This is the same image as Figure 7 except that some of the components have been labeled. At the very top of the image are three thumb screws used to collimate the secondary mirror. You can also see how off-centre the focuser is: no wonder SCTs have problems with mirror shift!

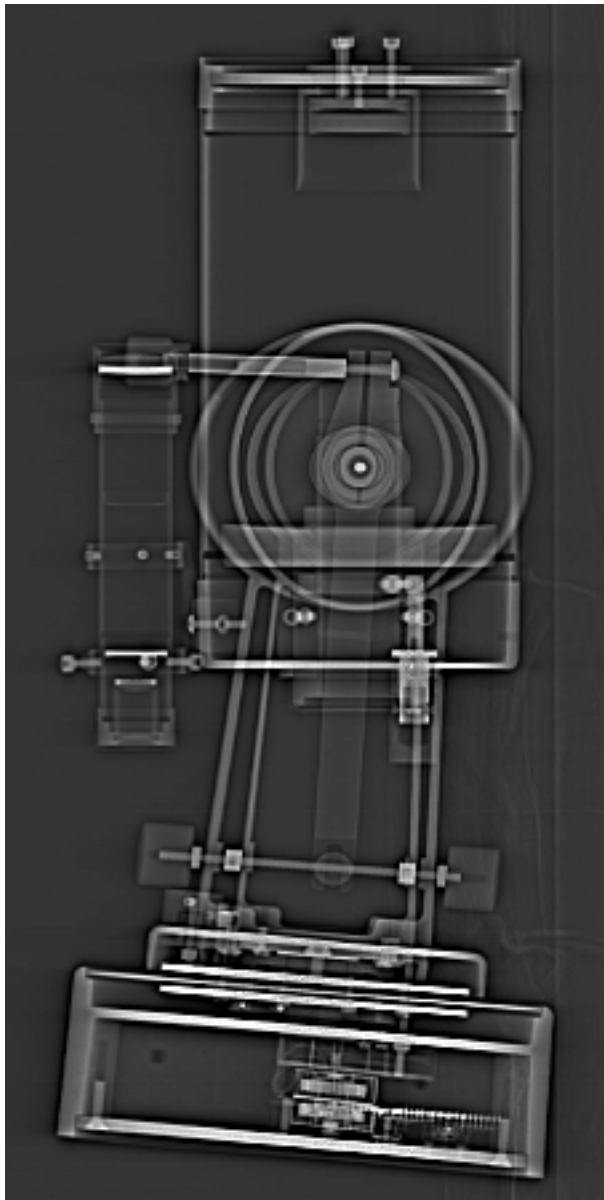
Figure 9 shows the scout view obtained 90 degrees with respect to Figure 7. Keep in mind that this is a scout scan for CT, not a proper radiograph (x-ray). Thus, this image is a bit confusing because of geometric distortion. Because the x-ray tube and detector are close together, objects closer to the tube are magnified more than objects closer to the detector. This is true of most x-ray images. For example, about one third of the way up from the bottom of this image, one can see the two forks that support the scope. In this image they appear to be different sizes even though they are the same: the fork that was closer to the x-ray tube appears larger in the image. Another problem is that because the object (SCT) is scanned linearly in one direction (top to bottom in these images), the magnification is only in one axis. Thus circular objects appear elliptical: in this image, the two setting circles appear as ellipses.

**Figure 9.** Scout view obtained 90 degrees with respect to Figure 7. In this image, the finder scope is on the left.

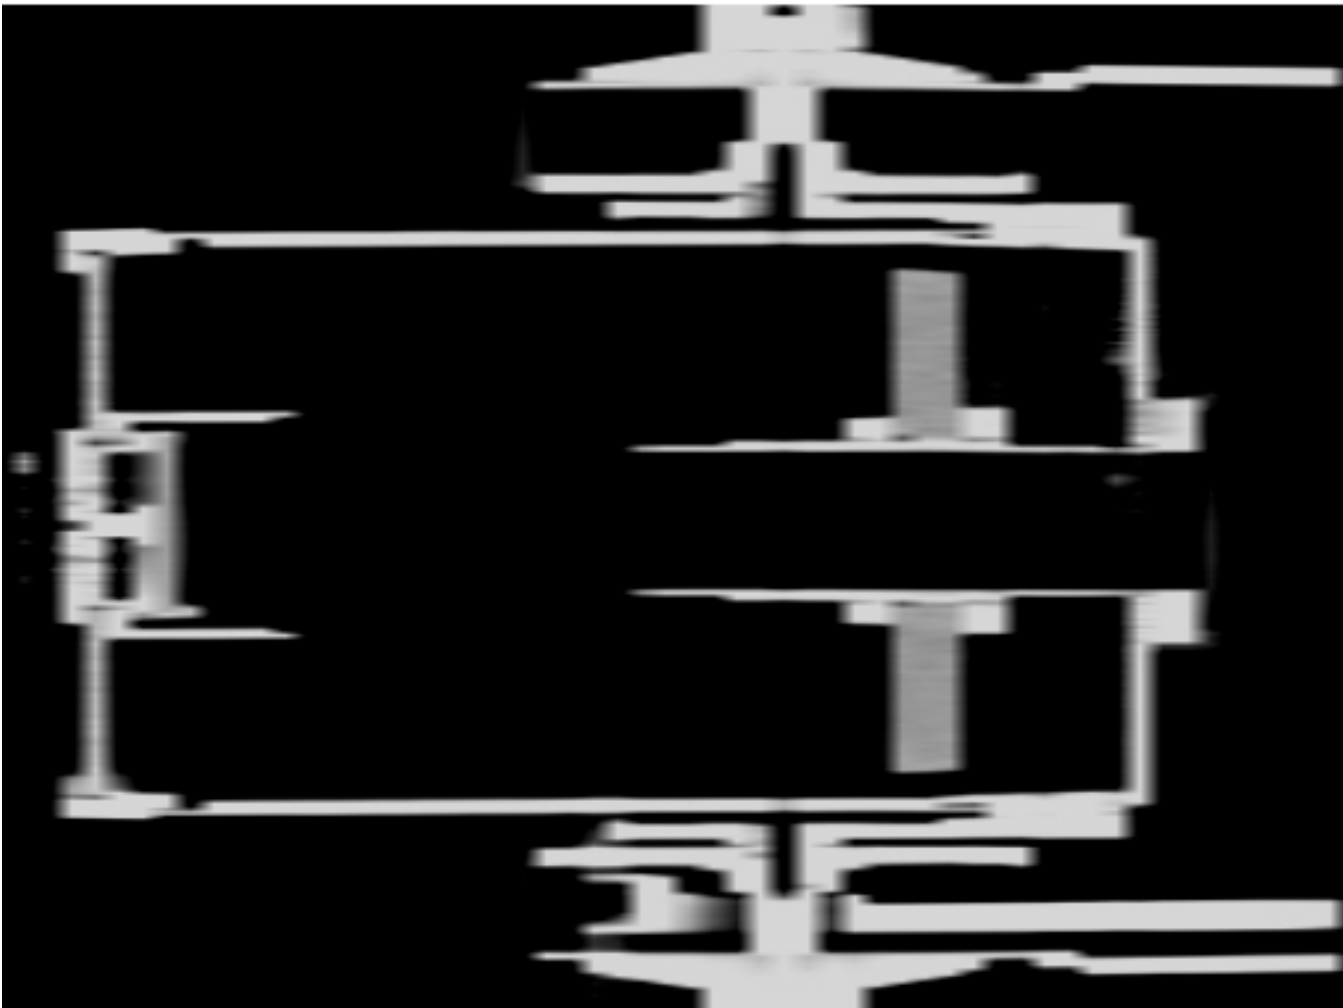
through (multi-planar reformatting) the three-dimensional image. These images show very nicely the internal structure of the scope. They also show that the mechanical assemblies are aligned, i.e. nothing is bent. Keep in mind that the relatively thick (2mm) image slices have introduced some artefacts into these images. For example, the secondary mirror looks too thin compared to the scout view.

**Figure 10.** This coronal image was formed by slicing through the three-dimensional image.

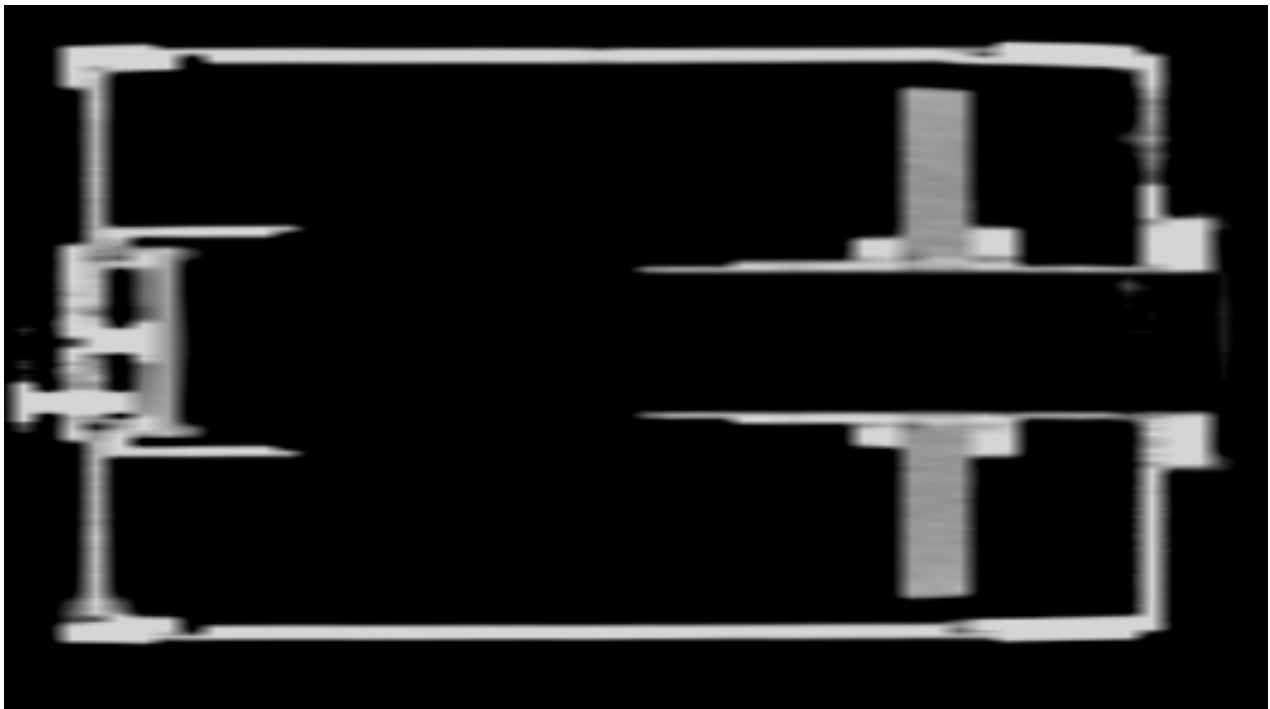
**Figure 11.** This sagittal image was formed by slicing through the three-dimensional image.

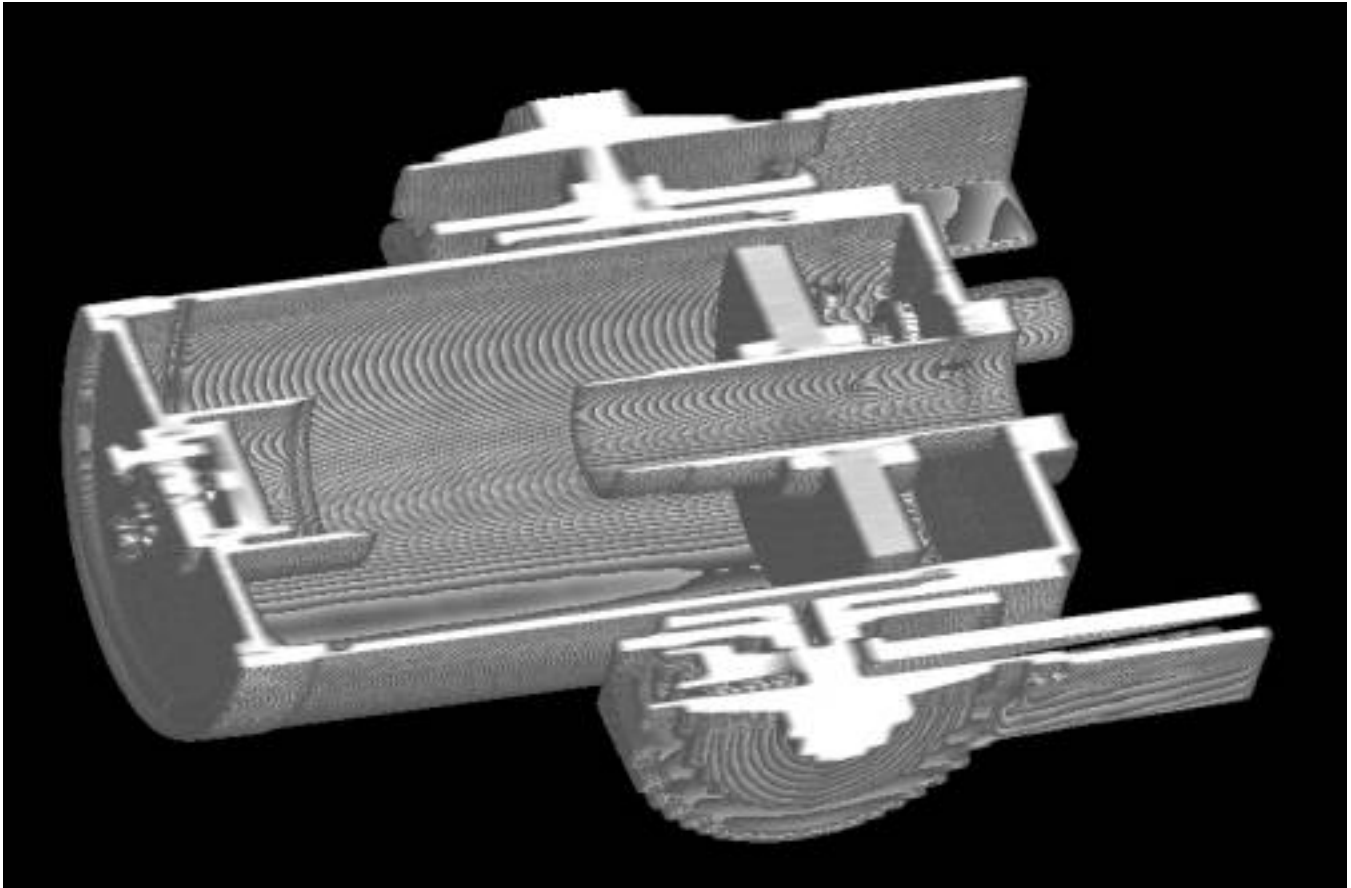
A volume-rendered view is shown in Figure 12. This shows the relative location of the internal components. The wood-grain "look" is an artefact introduced by the rendering software. The chunky-looking setting circles are a result of the 2 mm thick slices.

**Figure 12.** This is a rendered view of the scope showing its internal structure.
